**Flood Control Project Maintenance****2011 Structure Summary Report****Overall Unit and Item Ratings****Plumas County****North Fork Feather River Diversion Channel Drop Structure No. 1 Through 7**

**2011 Structure Inspection Results**

Structure
North Fork Feather River Diversion Channel Drop Structure No. 1 Through 7

Structure
North Fork Feather River Diversion Structure

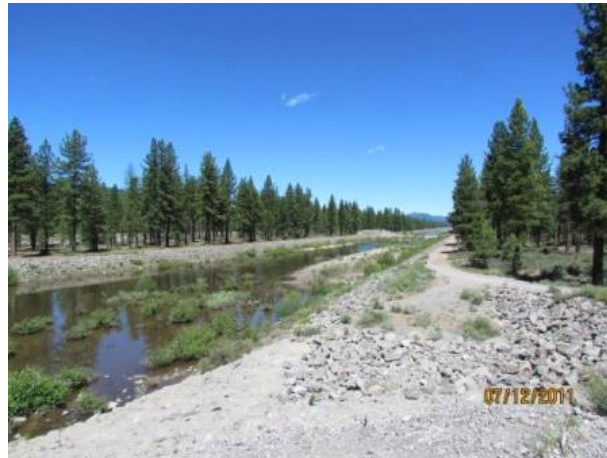
Levee Mile Report Line	1
Start Levee Mile	
End Levee Mile	
Location	
Category	Structures
Item	Photo Documentation

View of structure 7 looking towards 6 & 5.

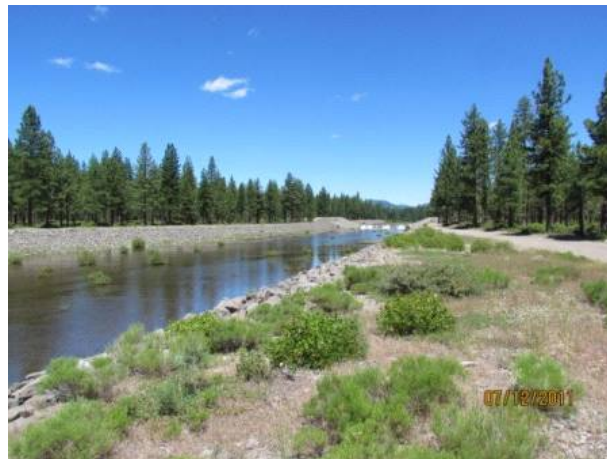
Levee Mile Report Line	15
Start Levee Mile	0.00
End Levee Mile	0.00
Location	
Category	Structures
Item	Concrete Surfaces

View of drop structure 1, looking towards the Feather River.

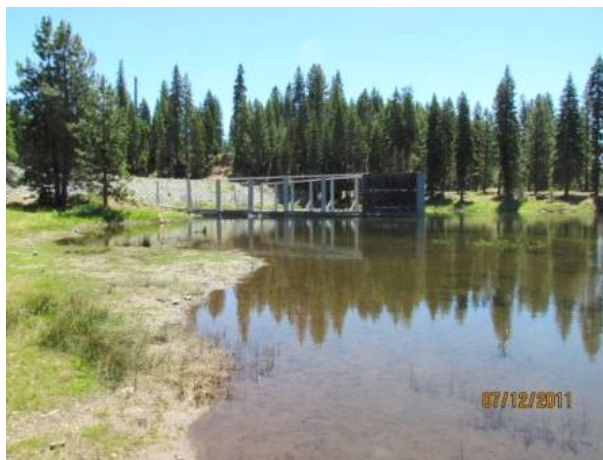
Levee Mile Report Line	1
Start Levee Mile	
End Levee Mile	
Location	
Category	Structures
Item	Photo Documentation

View of the dam & structure.

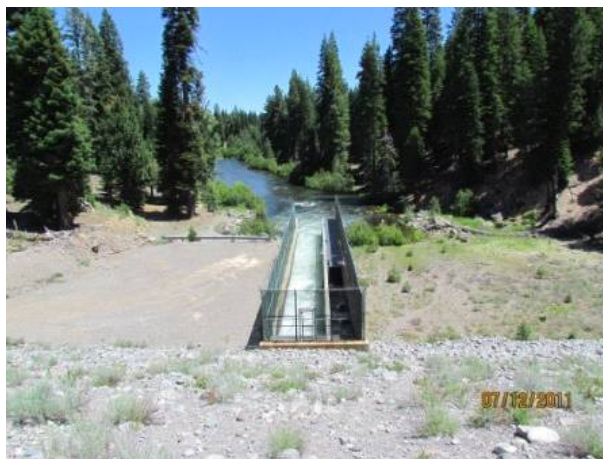
Levee Mile Report Line	2
Start Levee Mile	0.00
End Levee Mile	0.00
Location	
Category	Structures
Item	Vegetation & Obstructions

View of the outfall structure & slope of the dam.

LMR No.	Levee Mile		Category	Item	Location	Rating	Action/Comment	GPS Latitude/Longitude		Issue No.
	Start	End						Start	End	Photo
1			Structures	Photo Documentation				40.302640 ° 121.263190 °	40.302640 ° 121.263190 °	23 Y
2	0.00	0.00	Structures	Vegetation & Obstructions		A	Inspector Comments: Remove all vegetation from the face of the dam area before winter.	40.302810 ° 121.261940 °	40.302810 ° 121.261940 °	1 Y
3	0.00	0.00	Structures	Shoaling / Sedimentation		A		40.302640 ° 121.263190 °	40.302640 ° 121.263190 °	2
4	0.00	0.00	Structures	Erosion / Bank Caving		A		40.302640 ° 121.263190 °	40.302640 ° 121.263190 °	3
5	0.00	0.00	Structures	Revetments		A		40.302640 ° 121.263190 °	40.302640 ° 121.263190 °	4
6	0.00	0.00	Structures	Encroachments		A		40.302640 ° 121.263190 °	40.302640 ° 121.263190 °	5
7	0.00	0.00	Structures	Culverts: Inlets / Outlets		A		40.302640 ° 121.263190 °	40.302640 ° 121.263190 °	6

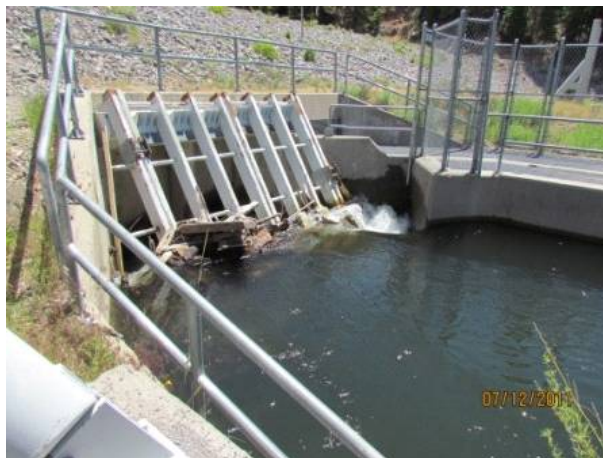
Levee Mile Report Line	10
Start Levee Mile	0.00
End Levee Mile	0.00
Location	
Category	Structures
Item	Trash Racks

View of the trash with little debris.

8	0.00	0.00	Structures	Culverts: Breaks / Holes / Cracks		A		40.302640 ° 121.263190 °	40.302640 ° 121.263190 °	7
9	0.00	0.00	Structures	Metal Pipes		A		40.302640 ° 121.263190 °	40.302640 ° 121.263190 °	8
10	0.00	0.00	Structures	Trash Racks		A	Inspector Comments: Remove all debris from the trash rack.	40.302750 ° 121.262170 °	40.302750 ° 121.262170 °	9 Y
11	0.00	0.00	Structures	Flap Gates		N	Inspector Comments: This item does not apply to this inspection.	40.302640 ° 121.263190 °	40.302640 ° 121.263190 °	10
12	0.00	0.00	Structures	Sluice/Slide Gates		A		40.302640 ° 121.263190 °	40.302640 ° 121.263190 °	11
13	0.00	0.00	Structures	Electric Gate Operators		N	Inspector Comments: This item does not apply to this inspection.	40.302810 ° 121.261940 °	40.302810 ° 121.261940 °	12 Y
14	0.00	0.00	Structures	Manual Gate Operators		A		40.302640 ° 121.263190 °	40.302640 ° 121.263190 °	13
15	0.00	0.00	Structures	Concrete Surfaces		A		40.302640 ° 121.263190 °	40.302640 ° 121.263190 °	14

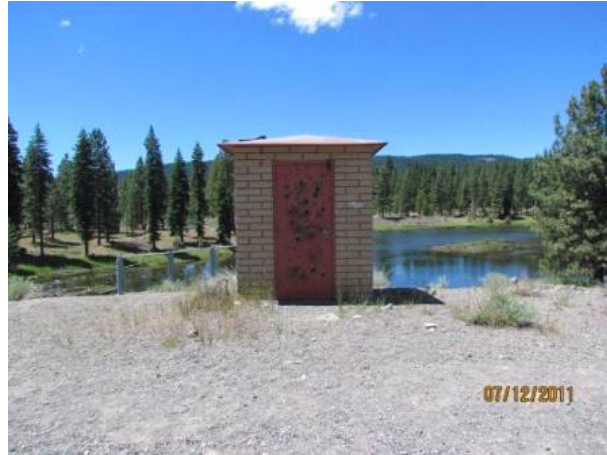
Levee Mile Report Line	13
Start Levee Mile	0.00
End Levee Mile	0.00
Location	
Category	Structures
Item	Electric Gate Operators
Gauging house on top of the dam, use discontinued due to vandalism.	
rduffey_t_20110726_013.jpg
